Technical Report

**Weathertightness testing of a
Porcelain Rainscreen fastened with a
Sikatack adhesive component by Sika**

N950/07/13951
1 DECEMBER, 2007

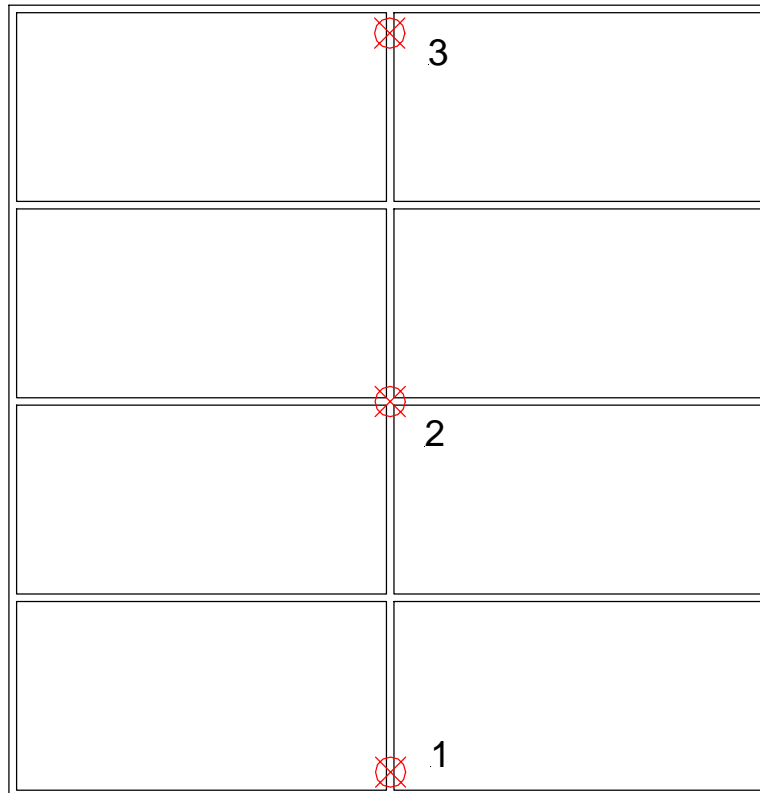
FIGURE 2

Gauge number	Member	Pressure differential (Pa)	Measured deflection (mm)	Residual deformation (mm)
2	Vertical support rail	2436 -2418	6.5 -7.1	0.0 -0.1

No damage to the test sample was observed.

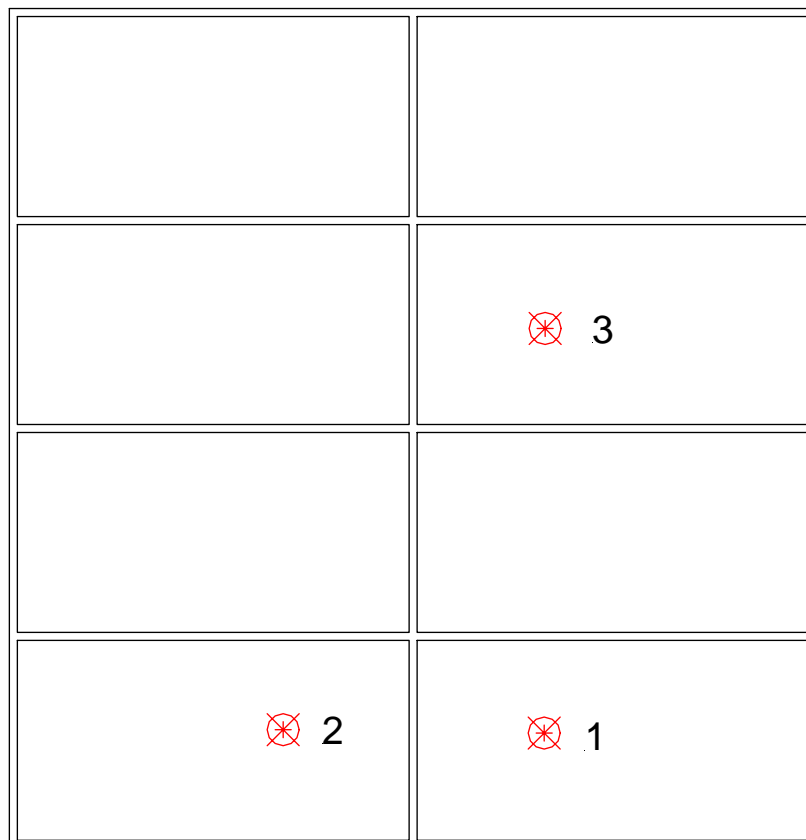
FIGURE 3

Location 2.

500 Nm soft body. Tile cracked but stayed secure.

Location 3.

10 Nm hard body. Star-shaped crack. Tile remained secure.

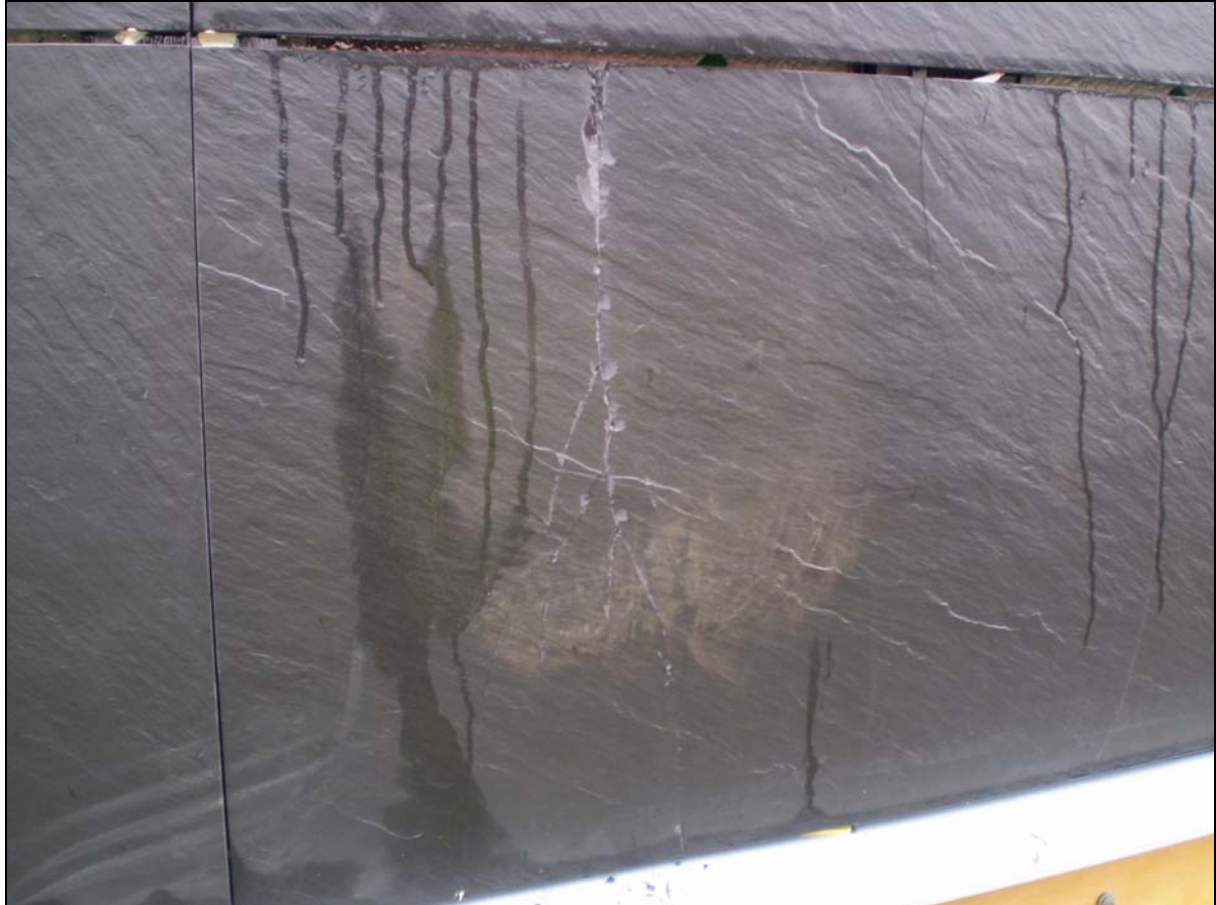
PHOTO 9270005

Location 1.

350 Nm soft body. Tile cracked from top to bottom but stayed secure.

LOCATION 1 IMPACT
