Technical Report

**Weathertightness testing of a
Porcelain Rainscreen fastened with a
Sikatack adhesive component by Sika**

N950/07/13951
1 DECEMBER, 2007

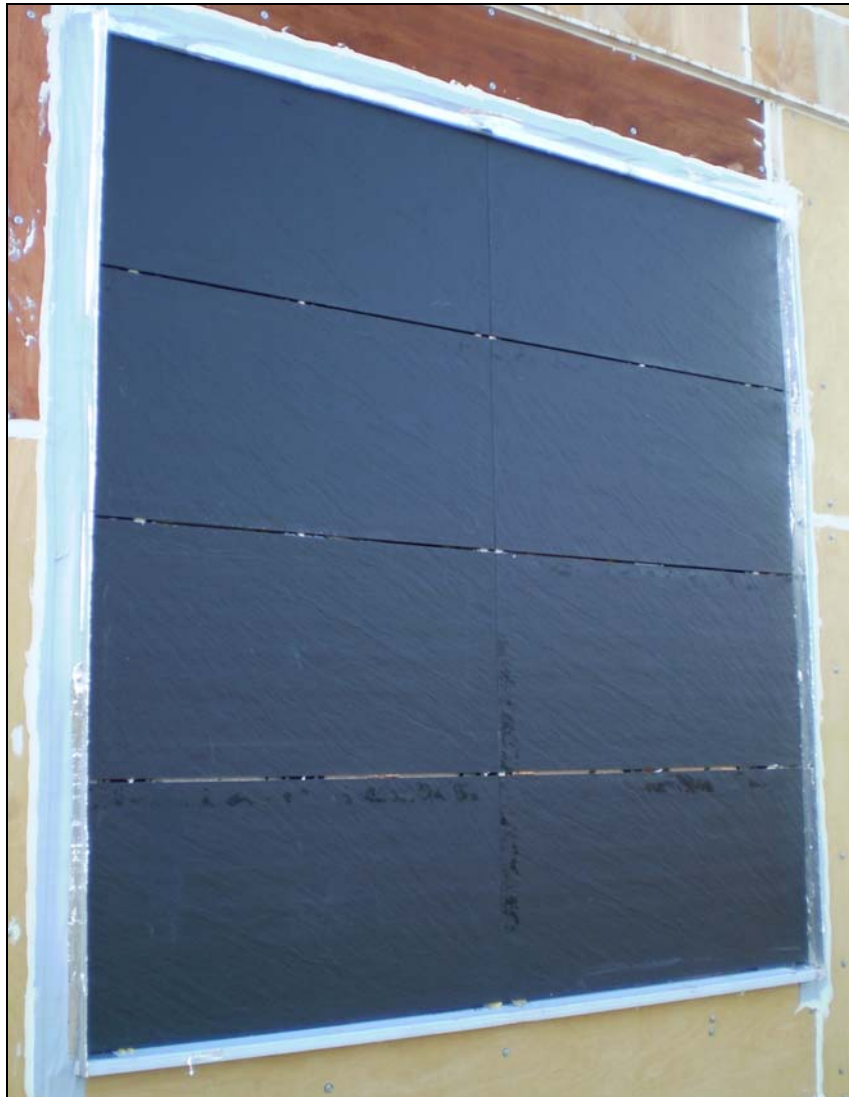
PHOTO 9270004

TEST SAMPLE ELEVATION

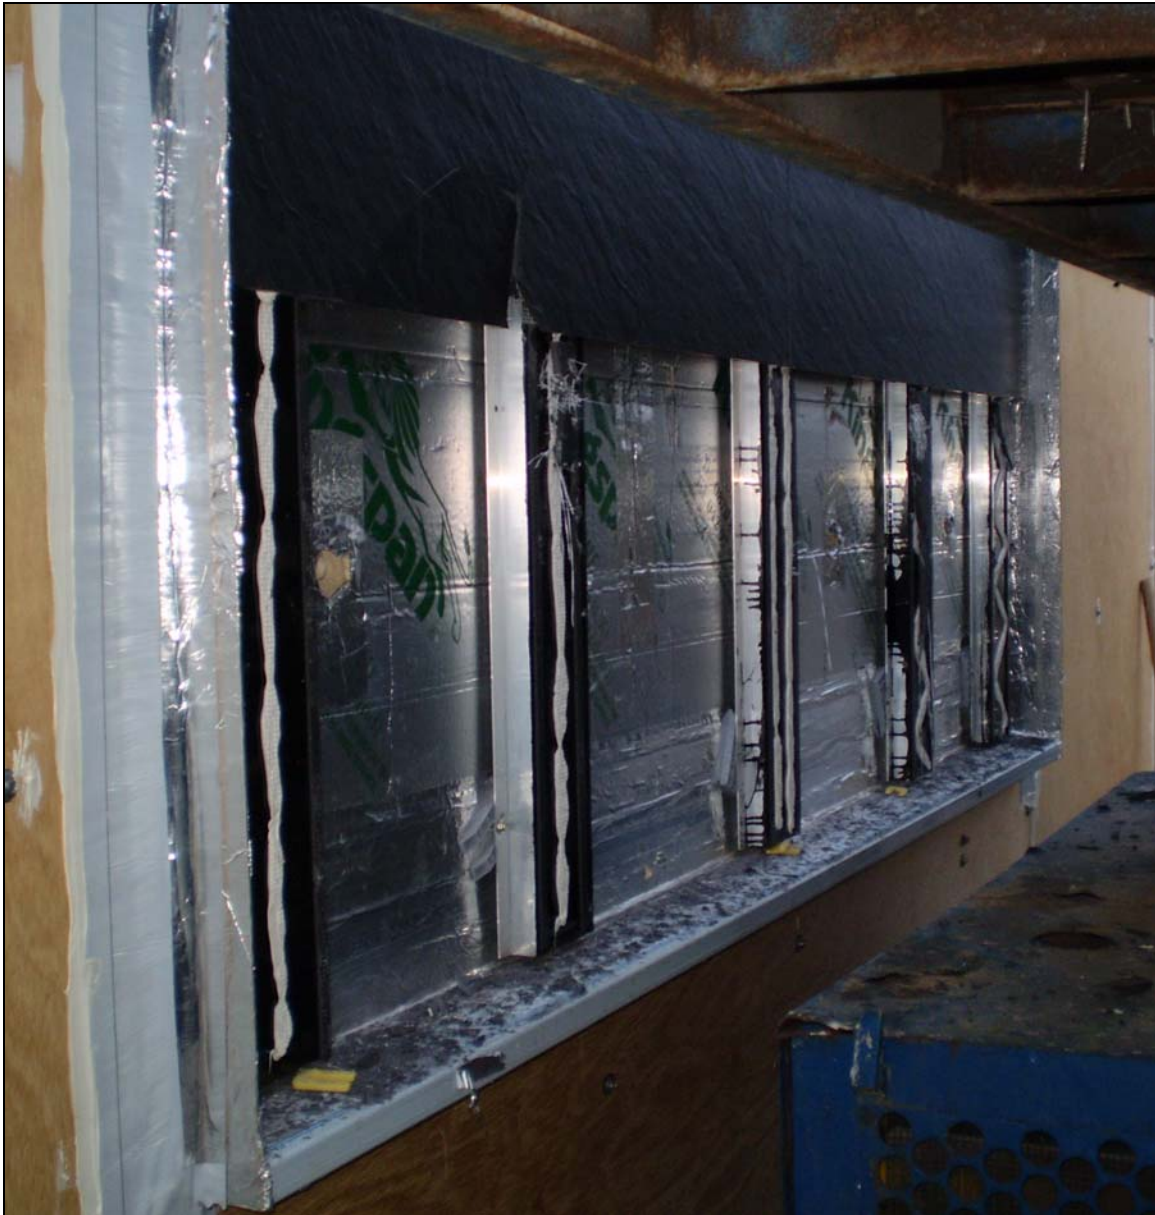
PHOTO 020001

During the dismantling of the sample no discrepancies from the drawings were found.

VERTICAL SUPPORT RAILS
